# FIFTY-YEAR PLUME RESPONSE TO SUCCESSIVE REMEDIAL MEASURES EMPLOYED WITH AN EVOLVING SITE CONCEPTUAL MODEL

47th Annual Environmental Show of the South May 17, 2018
David Heidlauf, CPG

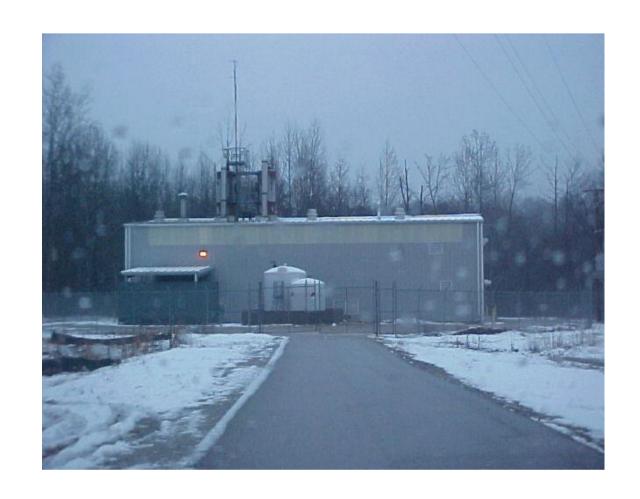
# **PUMP & TREAT 1997-2003**

- Ten extraction wells
- Air stripping & GAC
- GAC off-gas treatment
- Treated ~772,000,000 gal
- Removed ~110,000 lbs VOCs
- Hydraulic capacity: 525 GPM
- Operated at 220 GPM (02/03)
   (~50 % of target rate)
